Manhole Inspection Summary

Manhole # S07QQ1031MH

Location Address: **5206 NPARK HEIGHTS AVE** Cross Street: **BELVEDERE AVE**

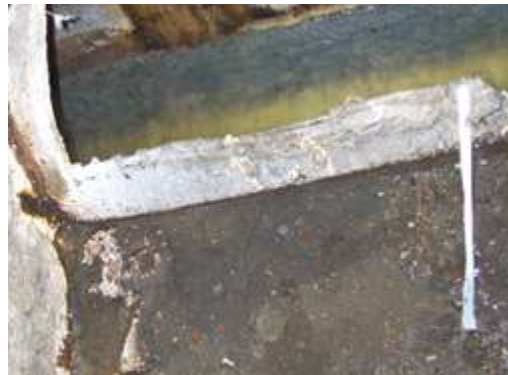
Defect 3

Condition: ☐ Sound ☐ Cracked ☐ Root Intrusion ☐ Deteriorated ☒ **Leaks** ☐ Debris

INFILTRATION BENCH- LOCATION UNKNOWN

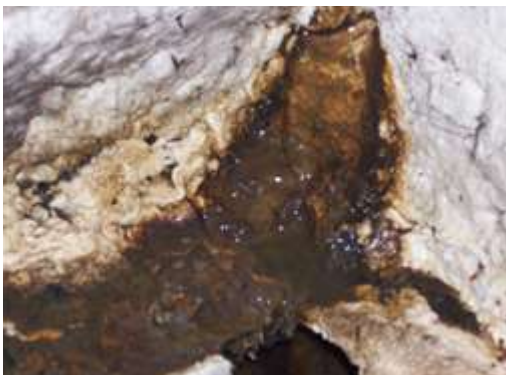
Defect 2

BENCH INFILTRATION - RUNNER

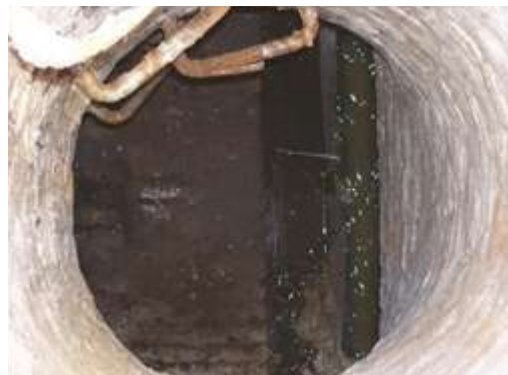
Defect 3

Steps Count: **8** Missing: **0** ☒ **Corroded**

CORRODED STEPS

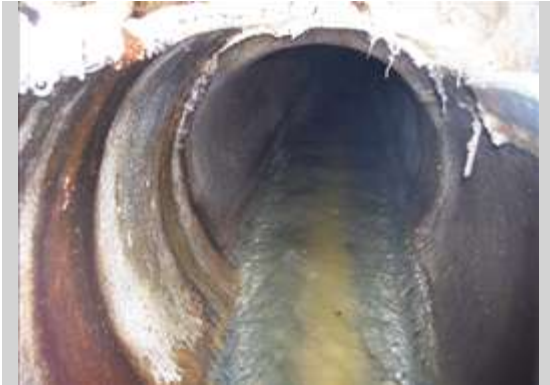
12 O'Clock Outflow

15 in. Circular Gravity Sewer
Pipe Out @ 12 O'Clock

Pipe Height: (in.) Direct
Pipe Material: **PVC** ☐ Pipe Lined
Invert Depth: **13.59** (ft.) Flow Characteristics: **Fast**
Deposits: ☒ None ☐ Mud ☐ Sludge ☐ Debris ☐ Grease
Silt Depth: (in.) Deposits Extent:
Infiltration: **None** Pipe Seal Cond: **Sound**

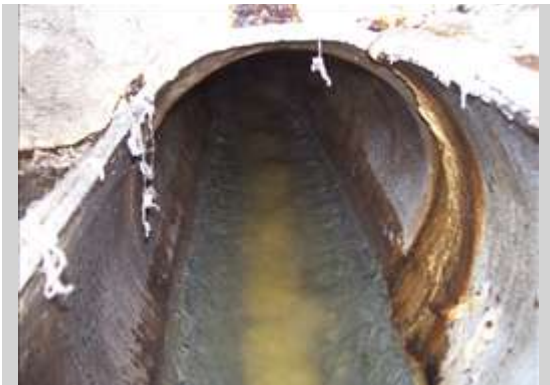
6 O'Clock Inflow

15 in. Circular Gravity Sewer
Pipe In @ 6 O'Clock

Pipe Height: (in.) Direct
Pipe Material: **PVC** ☐ Pipe Lined
Invert Depth: **13.52** (ft.) Flow Characteristics: **Fast**
Deposits: ☒ None ☐ Mud ☐ Sludge ☐ Debris ☐ Grease
Silt Depth: (in.) Deposits Extent:
Infiltration: **None** Pipe Seal Cond: **Sound**
